# THE ABILITY TO DEFECT OF STRESS CORROSION DEFECTS IN THE MAIN GAS PIPELINE AND CONDITIONS FOR THEIR DEVELOPMENT

Komarov Dmitry Valerievich

Lead Engineer of Technical Condition and ETC (Engineering and  
Technical Center) Consistency Management OOO Gazprom transgaz  
Samara

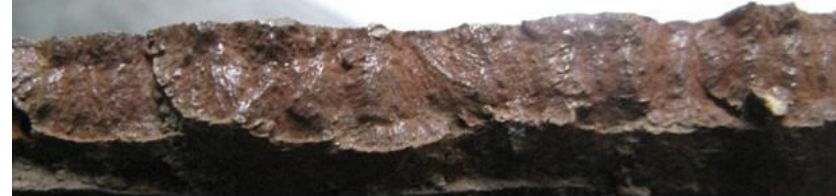
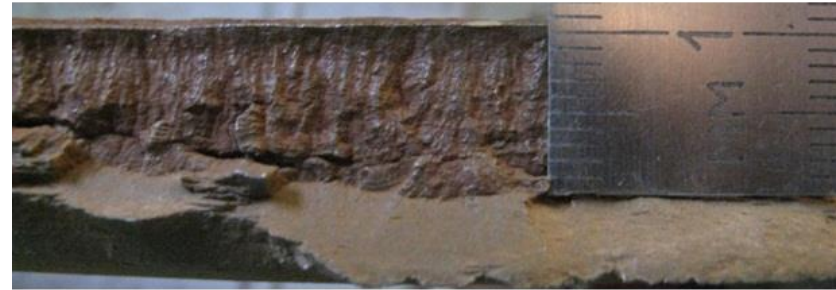
**A pit 35 × 11 m in size and up to 4.5 m deep was formed at the accident site.**

**As a result of the accident, a 26.5 m section of the gas pipeline was destroyed, with the release of two fragments of double-seam pipes.**

**The cause of the accident was the SCC defect located on the pipe of the Khartsizskiy pipe plant 1420 × 15.7 mm, manufactured in 1982, according to TU 14-3-995-81, from steel grade X70.**

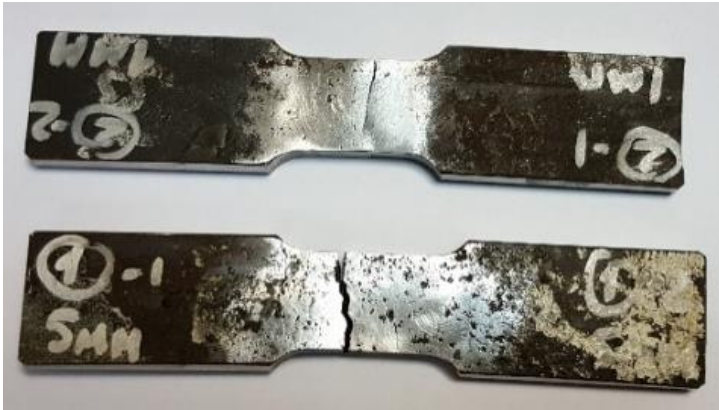
**View of destroyed specimens after fatigue tests on the UMP-01 installation**

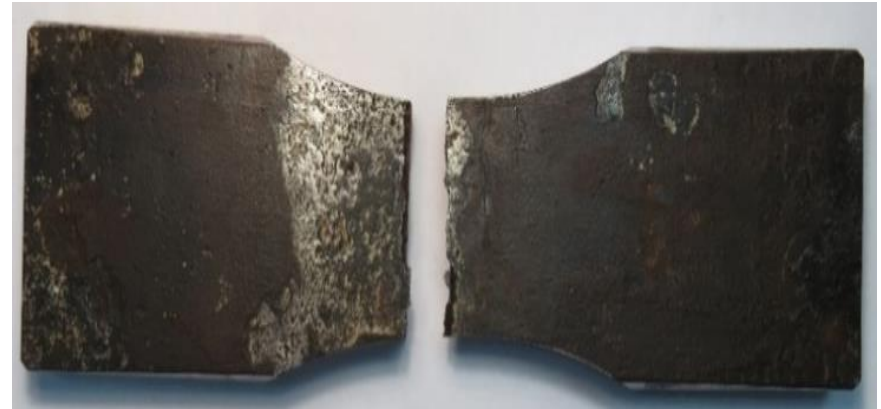
**View of destroyed specimens after fatigue tests on the UMM-01 installation**

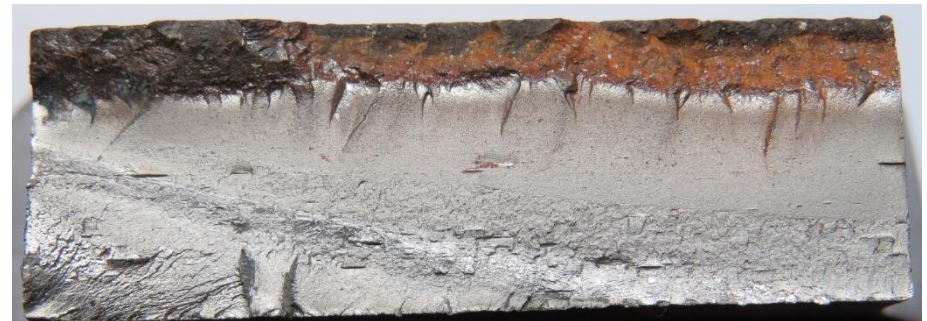
**General view of the fracture of a sample with an ILV crack, destroyed during fatigue tests**

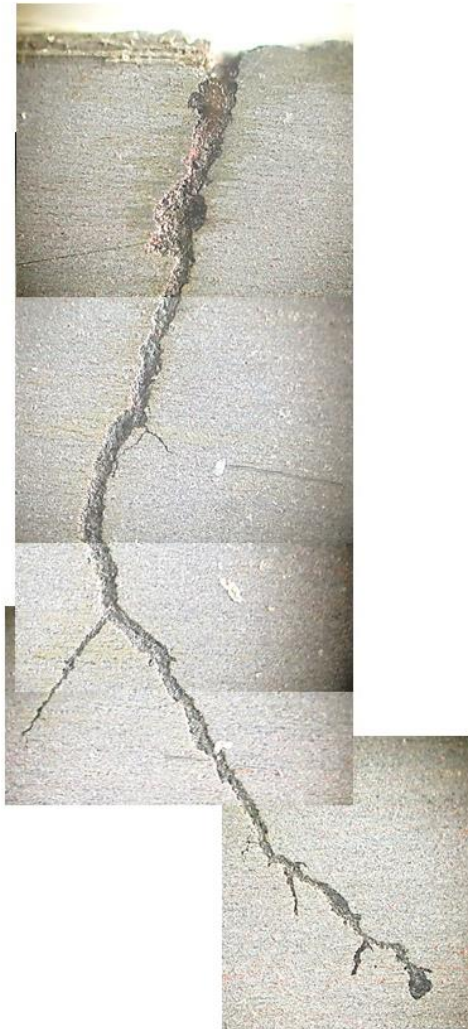
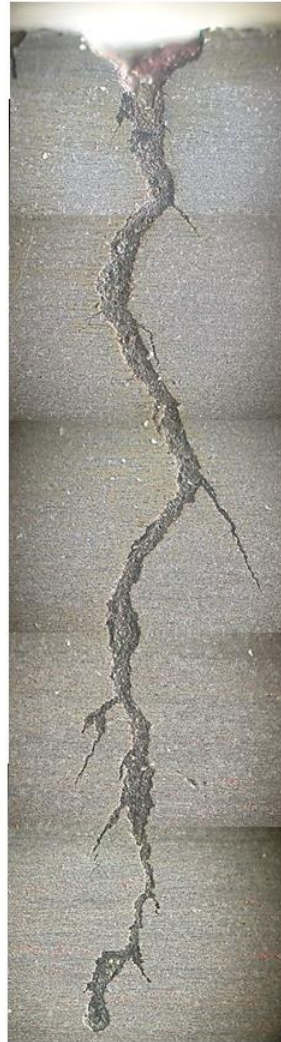
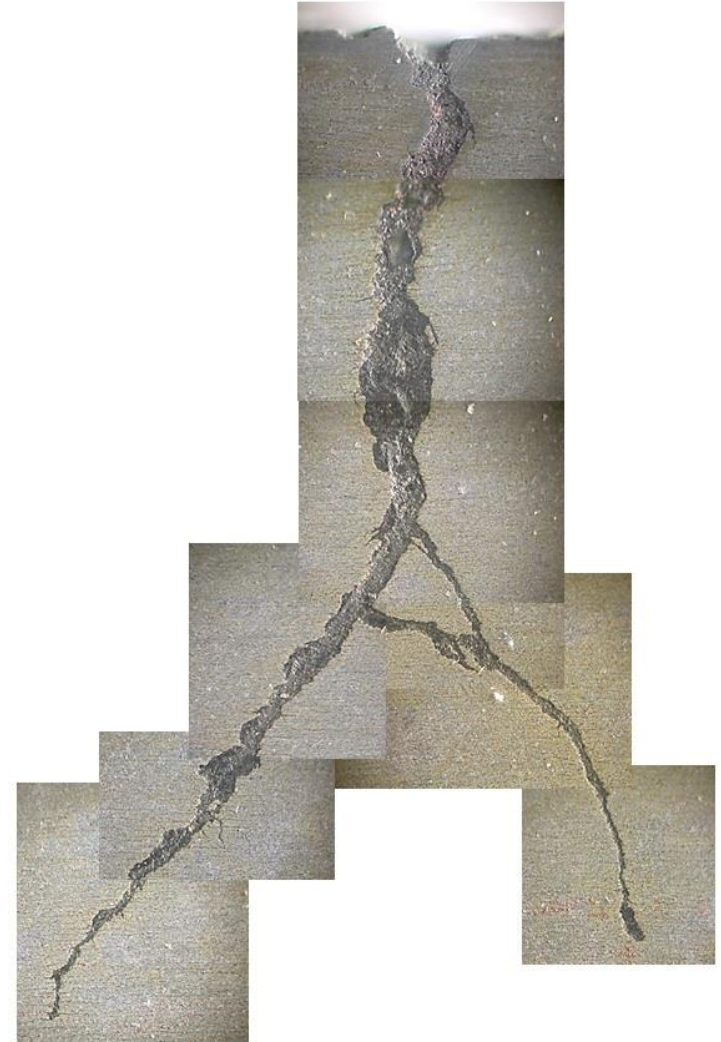
# The deepest SCC defects in the KR MG section of Gazprom Transgaz Samara, DN1400
