Corrosion Behavior of X80 Pipeline Under HVDC Interference

CNPC Tubular Goods Research Institute

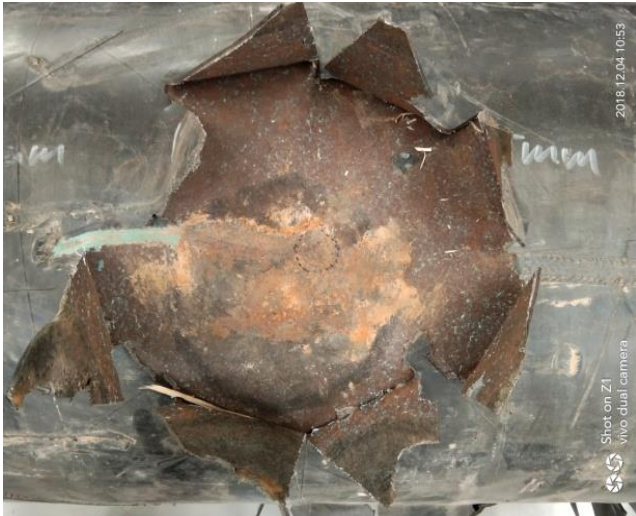
Coating damage

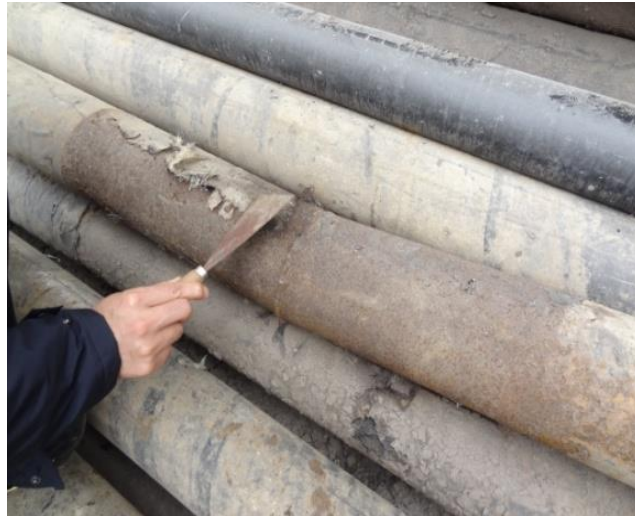
Cathodic disbonding

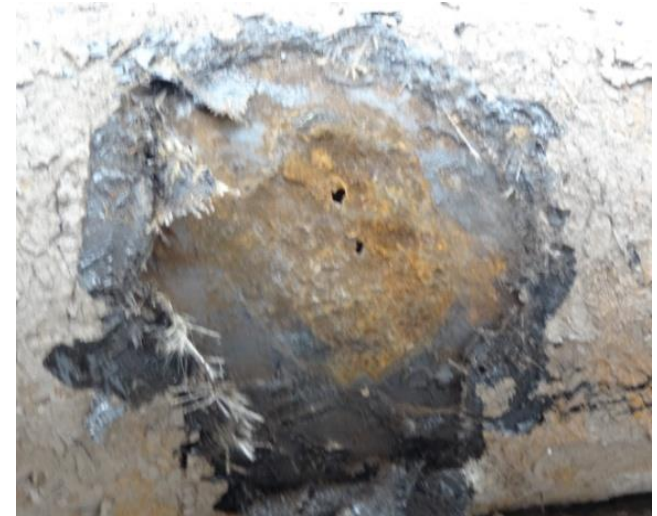
Corrosion perforation

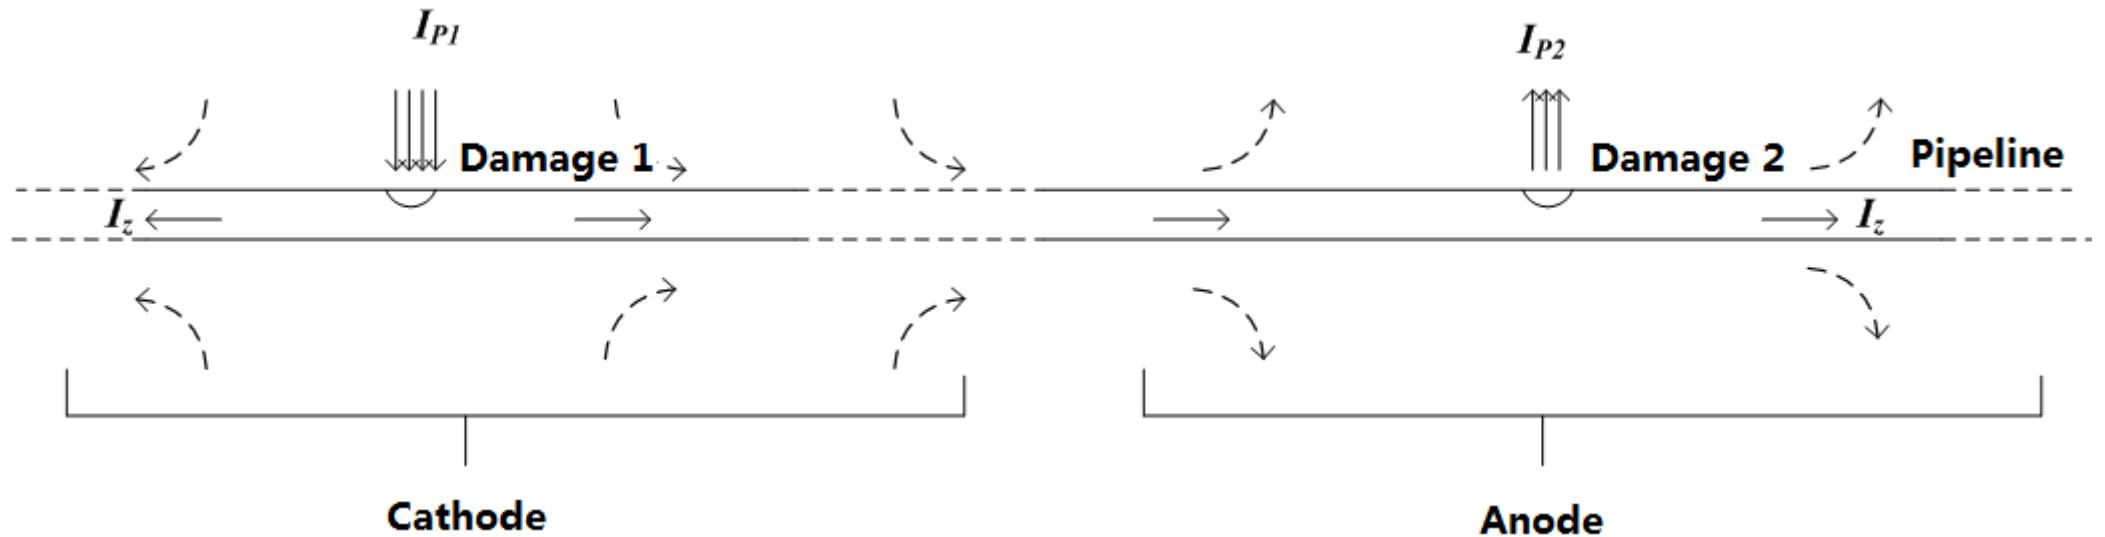
Mechanism of HVDC grounding pole interference

grounding electrode operate with single-pole induced high current into the ground

Oxygen reduction reaction or hydrolysis reaction

Corrosion of metals

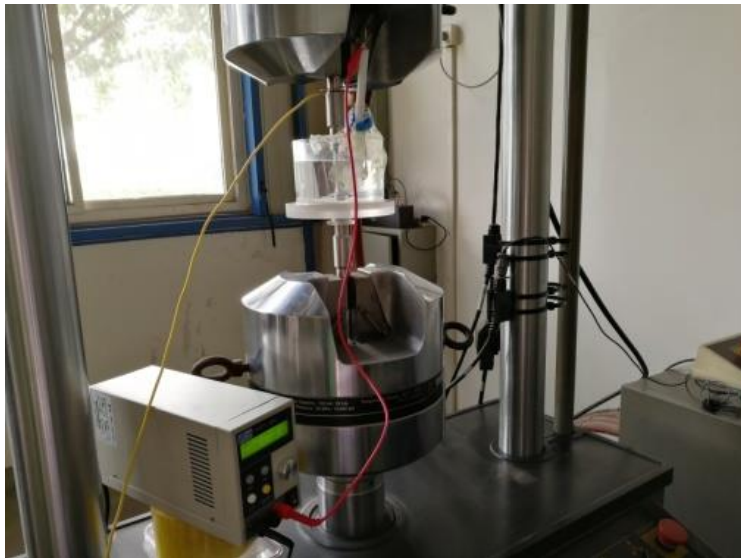
Hydrogen-induced damage test

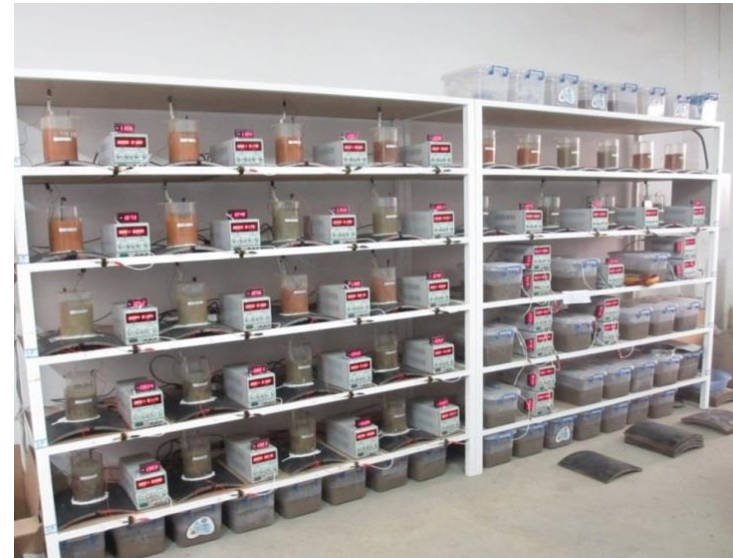
HVDC interference

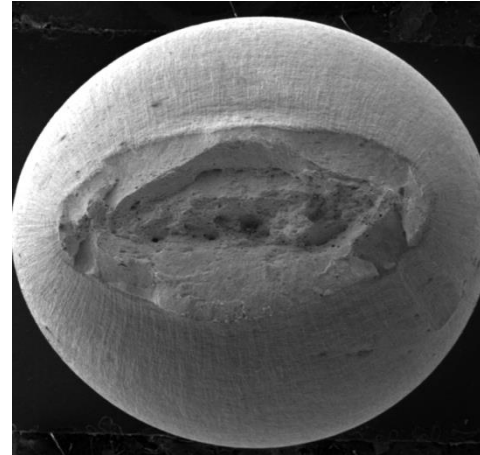
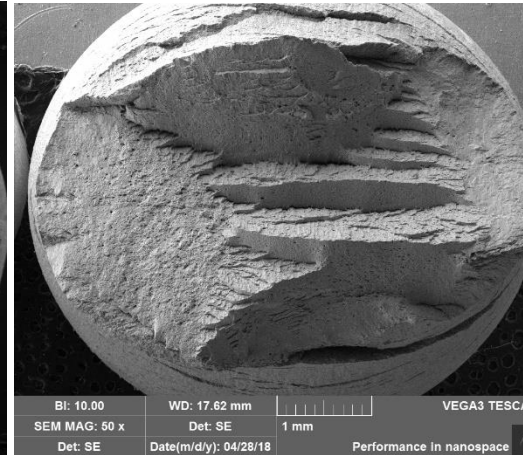
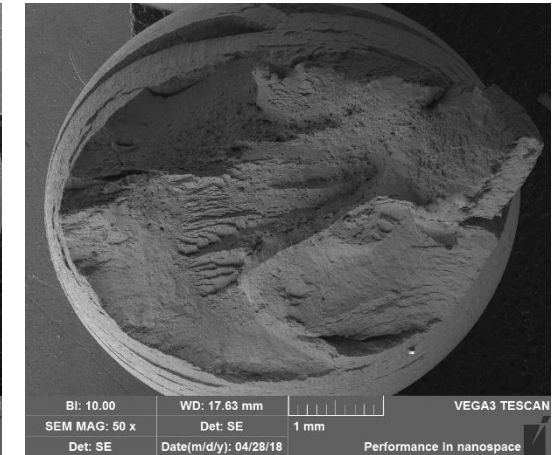
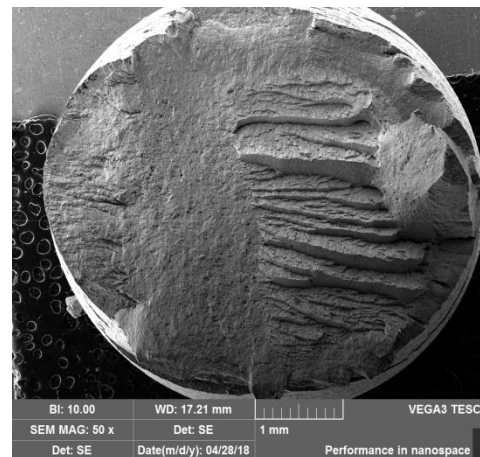
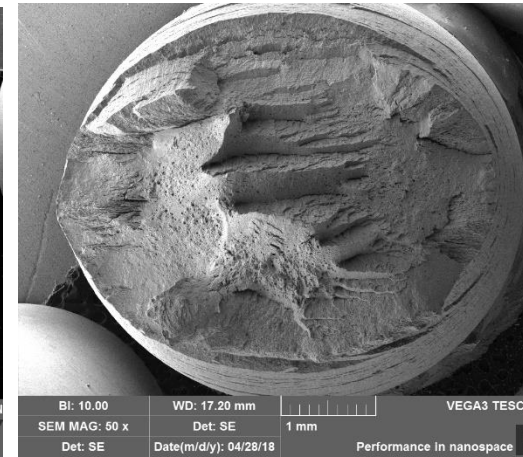
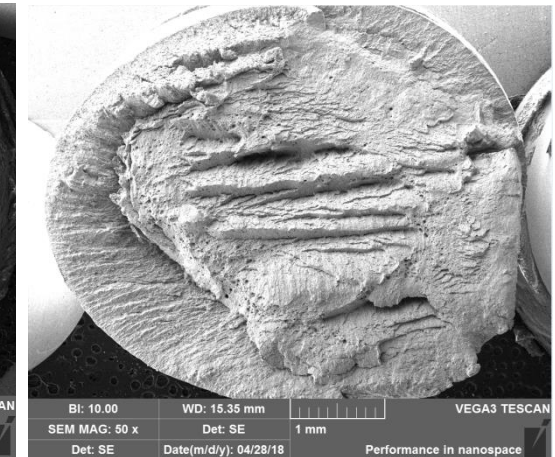
2.1.1 Effect of **current density** on the fracture characteristics of X80

- ✓ Several **cracks** appeared near the fracture surface
- ✓ **Brittle characteristic** zone on fracture surface

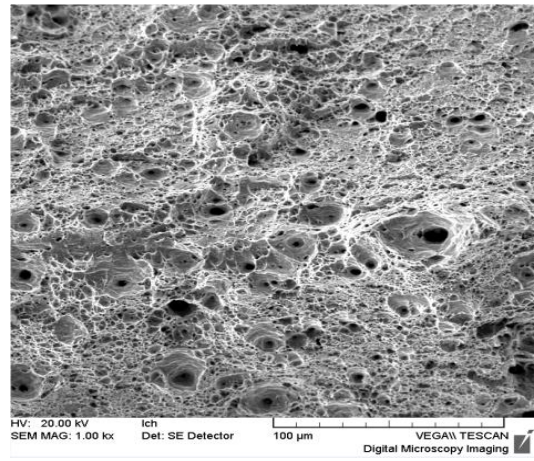
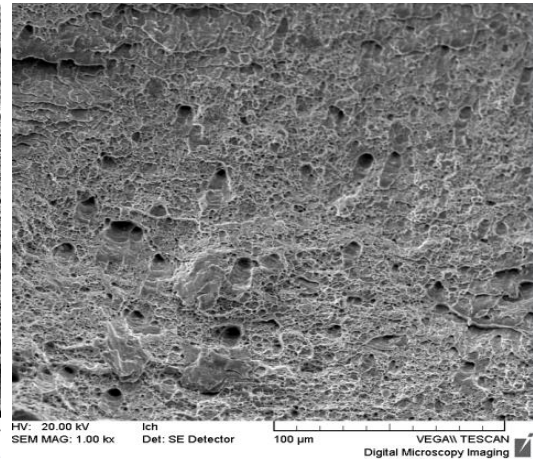
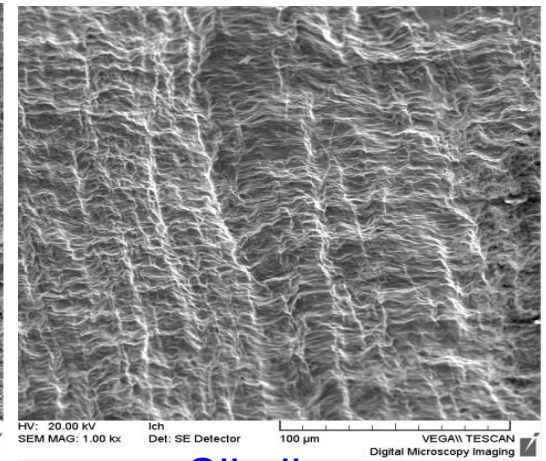
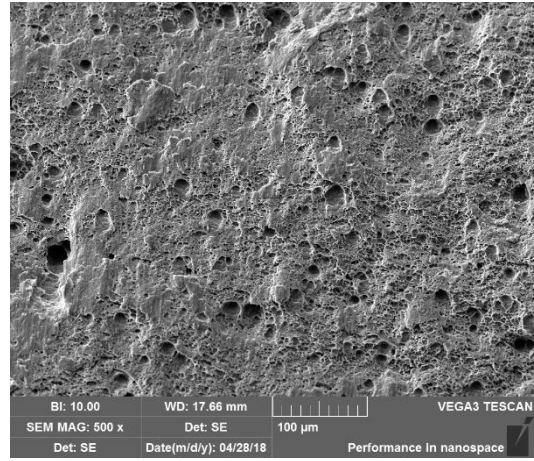
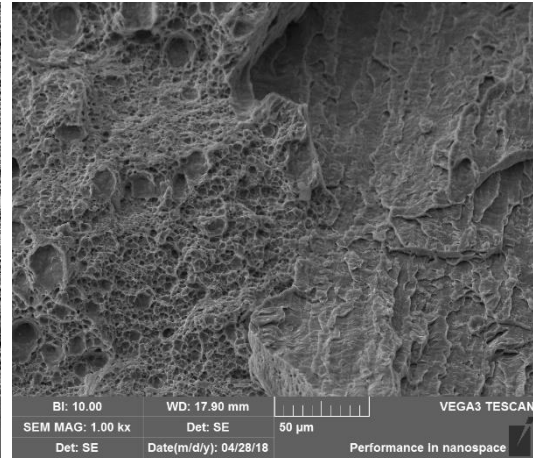
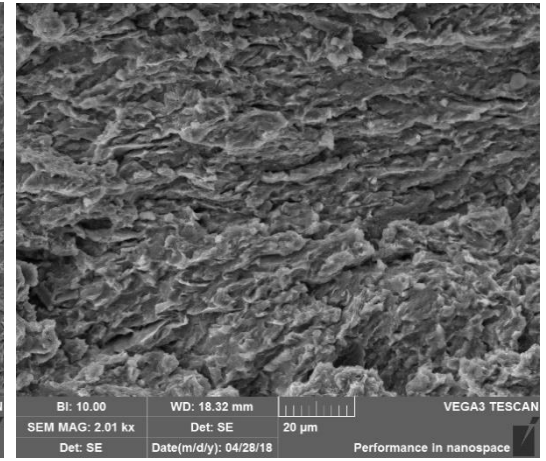
□ Effect of **current density** on the SEM morphology of X80 fracture

Brittle fracture characteristics appeared on fracture surface

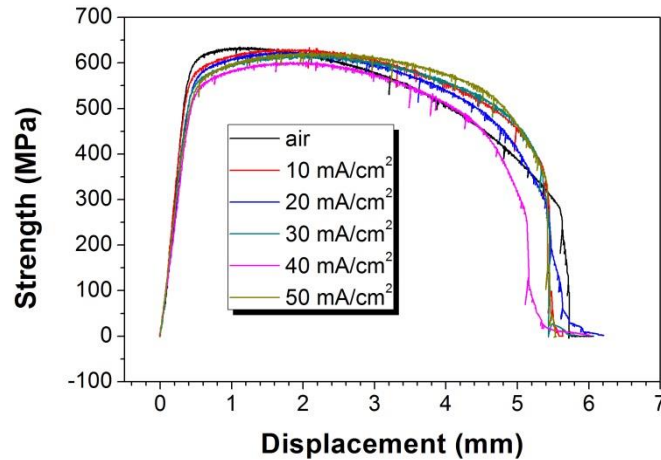
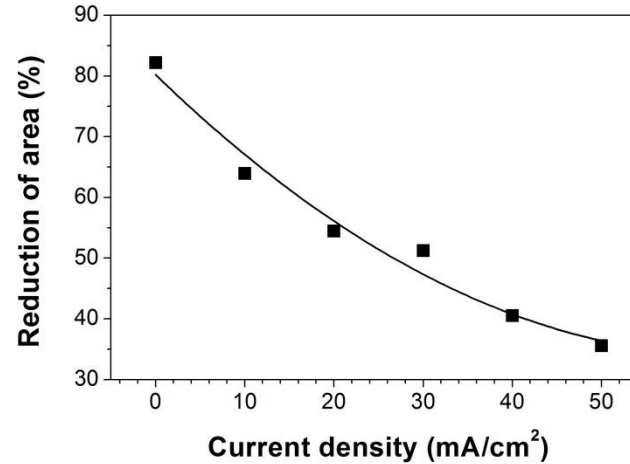
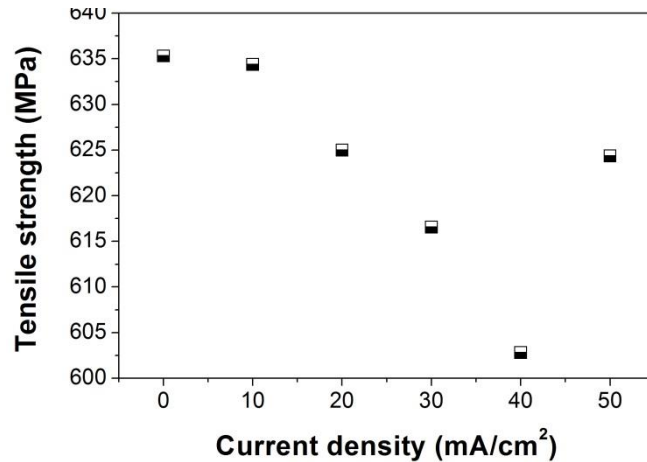
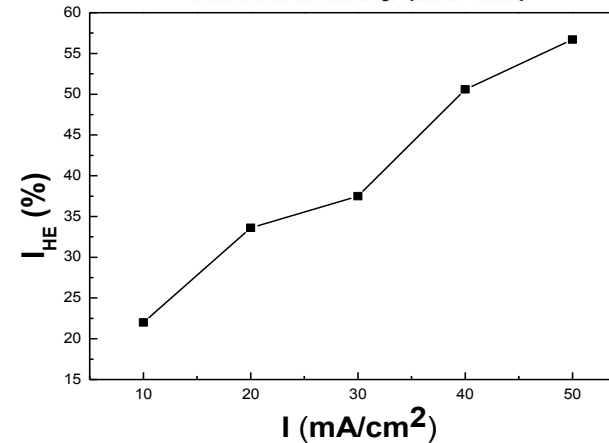
□ Effect of **current density** on the mechanical properties of X80

- ✓ The tensile strength decreased slightly as the current goes up, the maximum change is 22MPa.
- ✓ The reduction of area **decreased** and the material **plastic loss was obviously** with the increasing of current density, there is a higher risk of brittle fracture when $I > 20 \text{ mA/cm}^2$.

- The damage caused by **HVDC interference** with hydrogen is mainly reflected in the decrease of **plastic property** of the material, and its tensile strength has no significant effect.

- The **current density/voltage** is the most important factor that affects the brittleness of fracture.
- When the current density is **$\geq 10\text{mA/cm}^2$ (-15v)**, hydrogen damage has occurred. When the current density is **$> 20\text{mA/cm}^2$** , I_{HE} is greater than **35%**, which has entered the fracture zone.

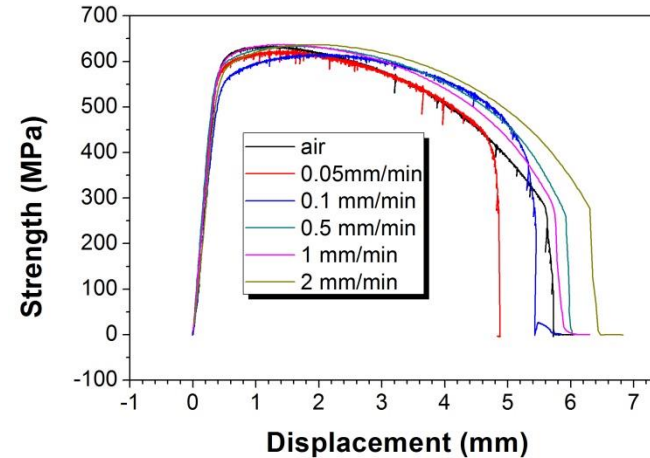
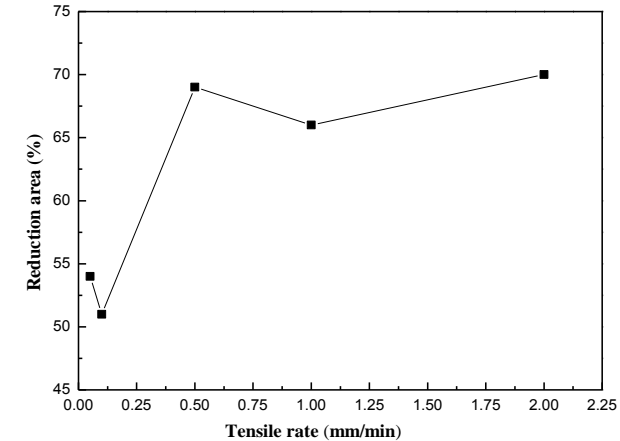
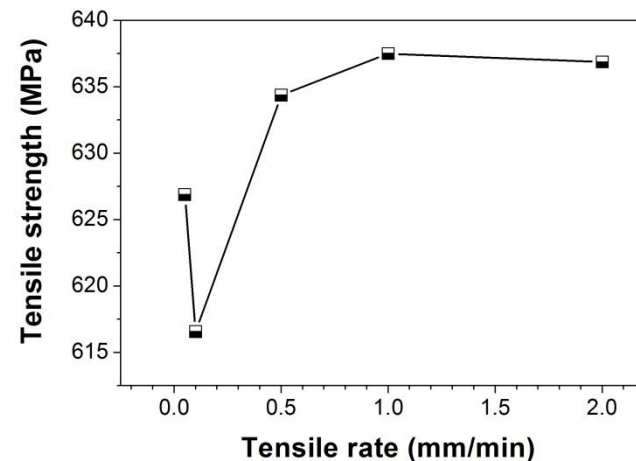
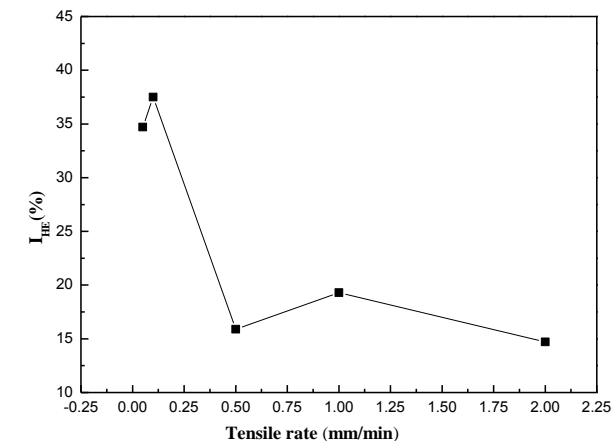
2.1.2 Effect of tensile rate on the mechanical properties of X80

- ✓ With the increase of tensile rate, the fracture time was significantly **shortened**, reduction area **goes up**, and sensitivity **dropped**.
- ✓ The lower tensile rate supplied enough hydrogen charging time and benefited for the invasion of hydrogen atoms, when $v > 0.5\text{mm/min}$ the risk of brittle reduced.

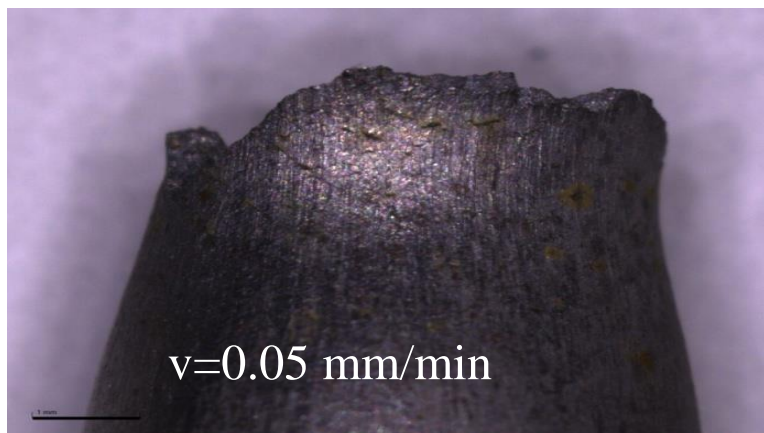
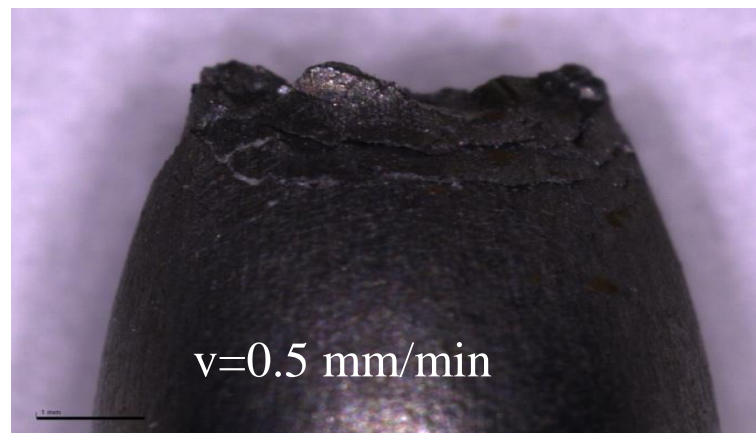
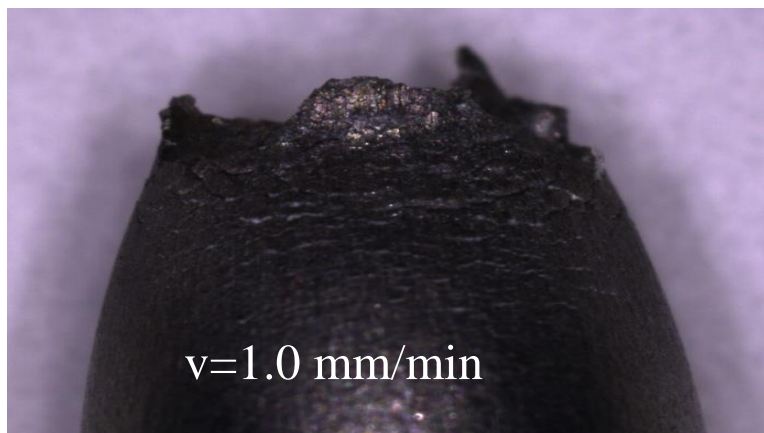
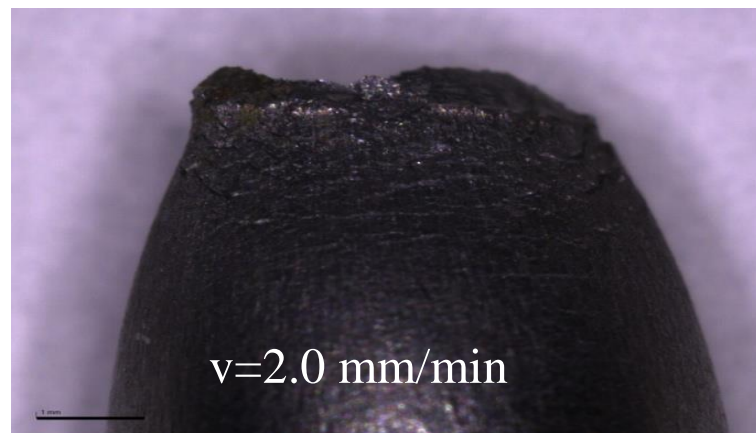
Crack near fracture

- ✓ With the increase of tensile rate, the size and density of the crack in the side wall of the fracture increased, while the necking increased.
- ✓ The increase of tensile rate promotes the surface crack propagation.

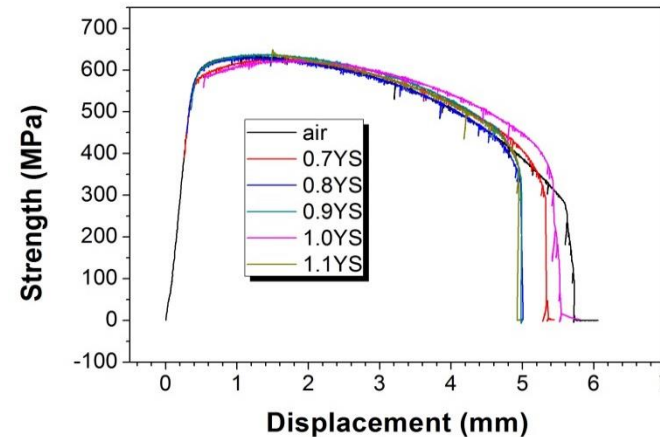
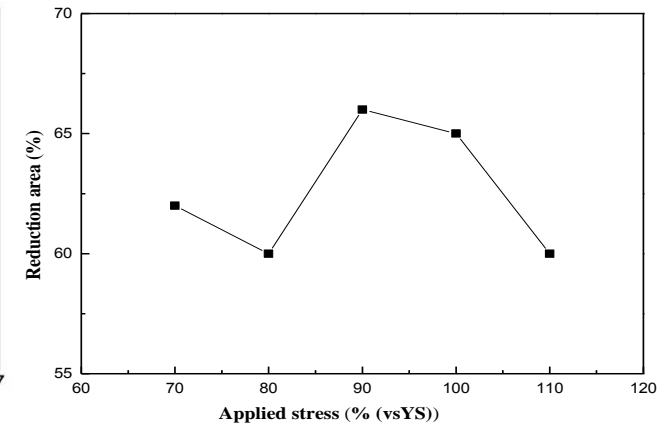
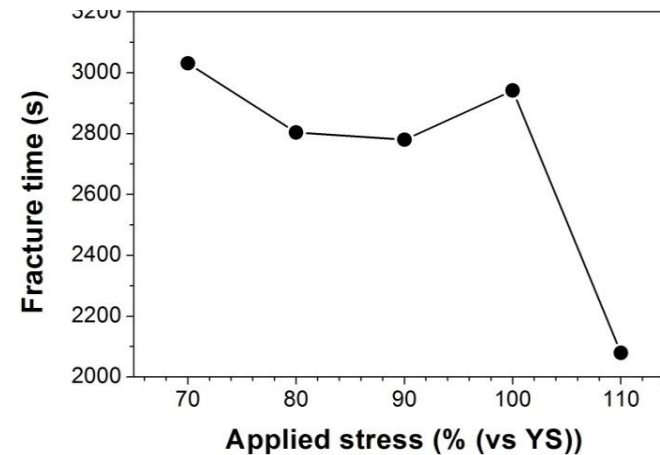
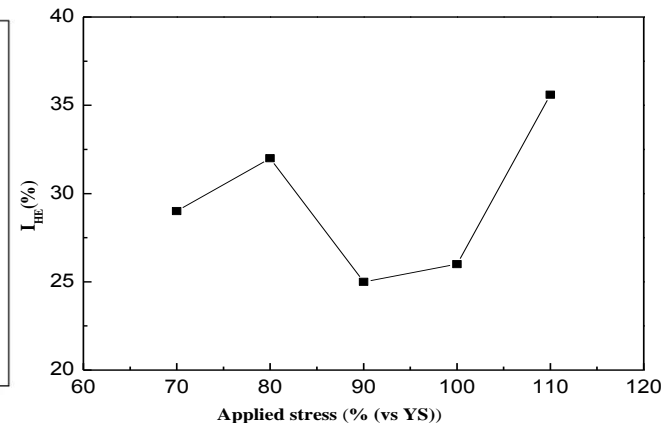
2.1.3 Effect of **tensile stress** on the mechanical properties of X80

- ✓ When stress less than 100%SMYS, the reduction of area raises with increasing tensile stress.
- ✓ When stress exceed 110%SMYS, the reduction of area decreases greatly.

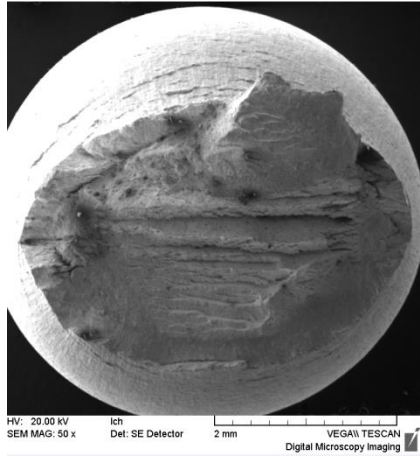
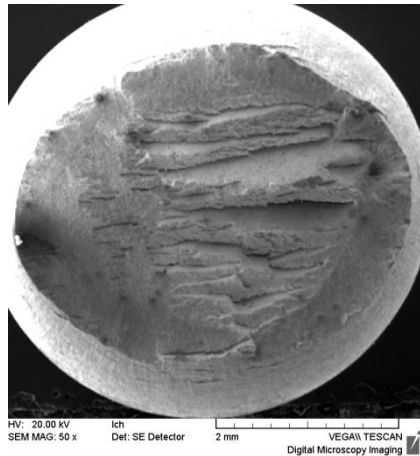
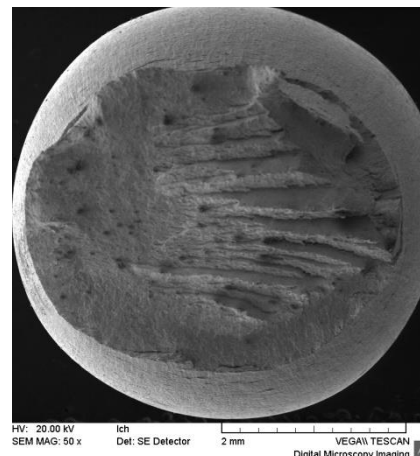
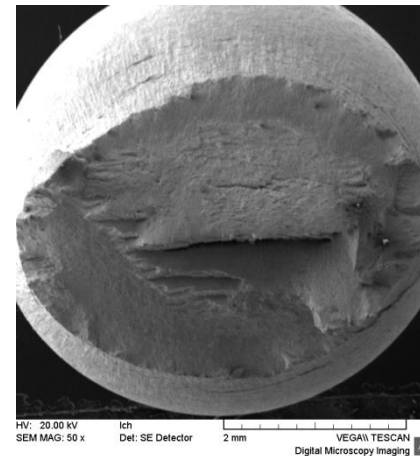
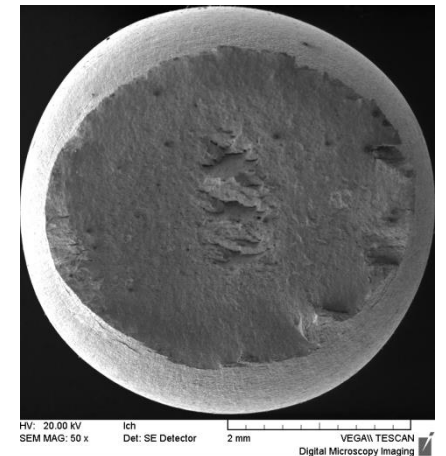
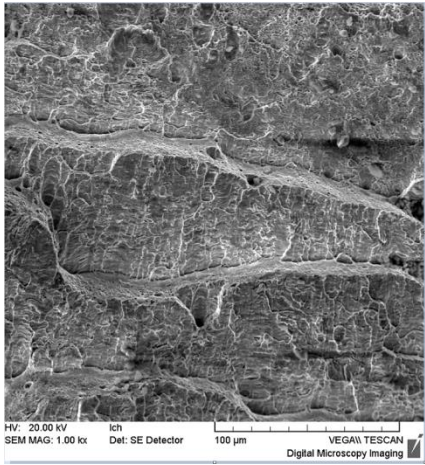
□ Effect of **tensile stress** on the fracture morphology of X80

✓ Brittle fracture occurs on all conditions.

✓ Crack density decreased with the tensile stress increasing.

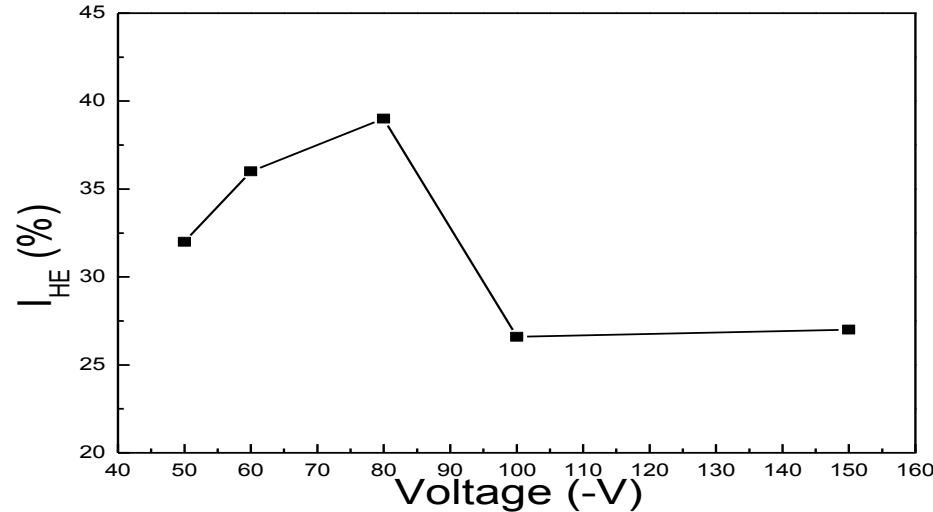
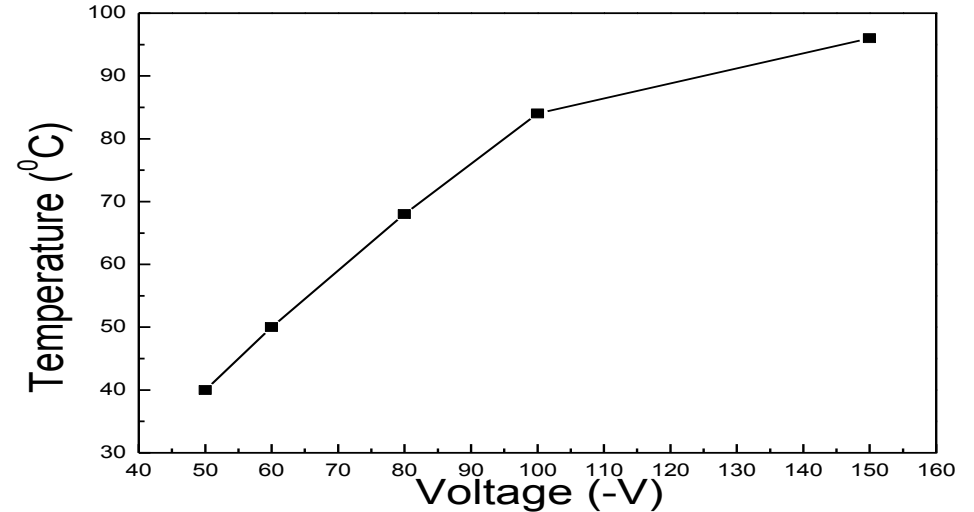
2.1.4 Effect of **interference voltage** on the mechanical properties of X80

- ✓ The hydrogen embrittlement sensitivity increased when the interference voltage between **-50~-80V**. When the interference voltage is lower than **-100V**, the sensitivity of HE stays at a relatively stable level.
- ✓ When the interference voltage between **-50~-80V**, x80 sample is in **brittle zone**. When the interference voltage is shift to **-100V**, the brittleness risk reduced.
- ✓ The above phenomenon was related to the **rapid increase of solution temperature** caused by high voltage interfere, and the excessive temperature caused the change of system resistance and accelerated the escape of H_2 .

- When the interference voltage is between **-50~ -80V**, the I_{HE} of X80 is greater than **30%**, which belongs to extreme hydrogen damage and has a high risk of brittle cracking. As the voltage moves below -100V, the hydrogen embrittlement sensitivity decreased.

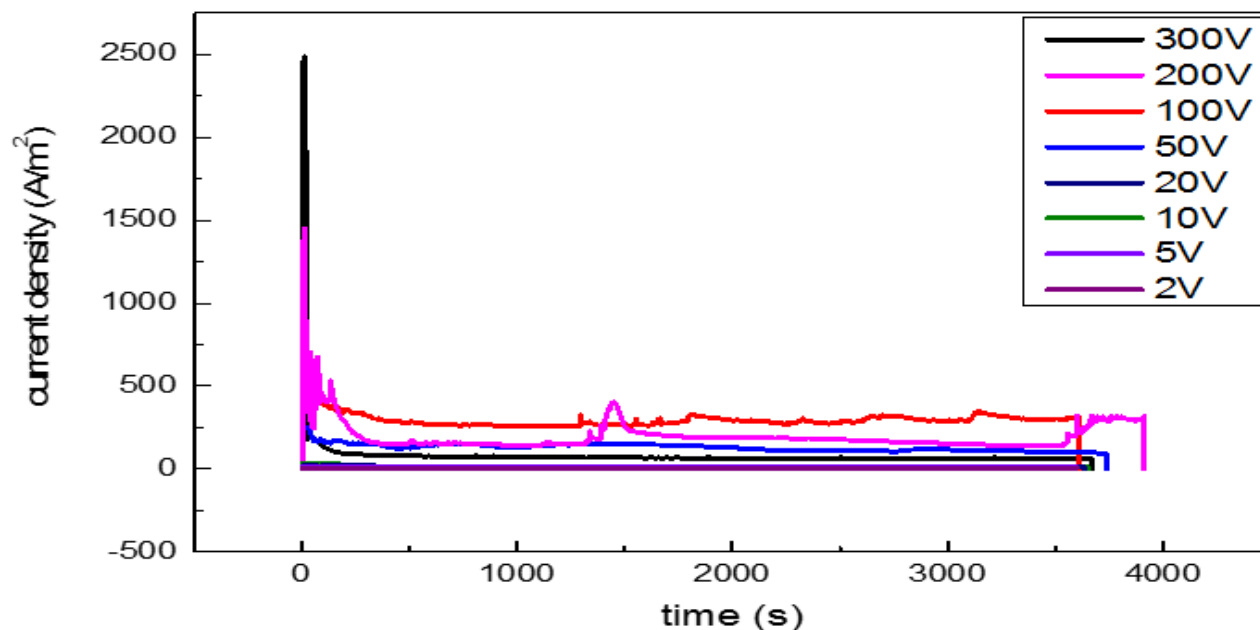
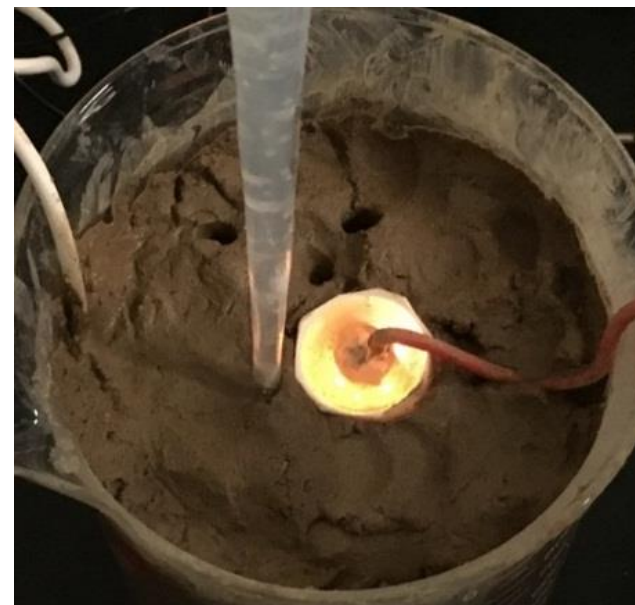
2.2.1 High Voltage DC Interference Test in Soil

- ✓ When the interference voltage is high (above 50V), the interference current density changes greatly with time.
- ✓ High voltage direct current interference energy is large, which results in the temperature of soil rise obviously.

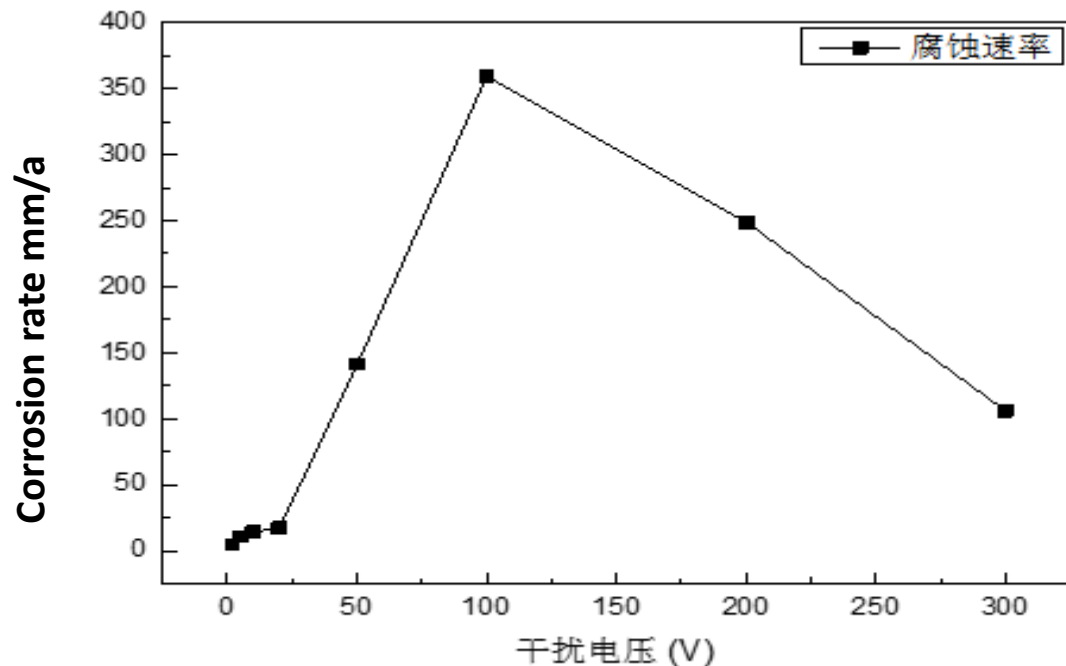
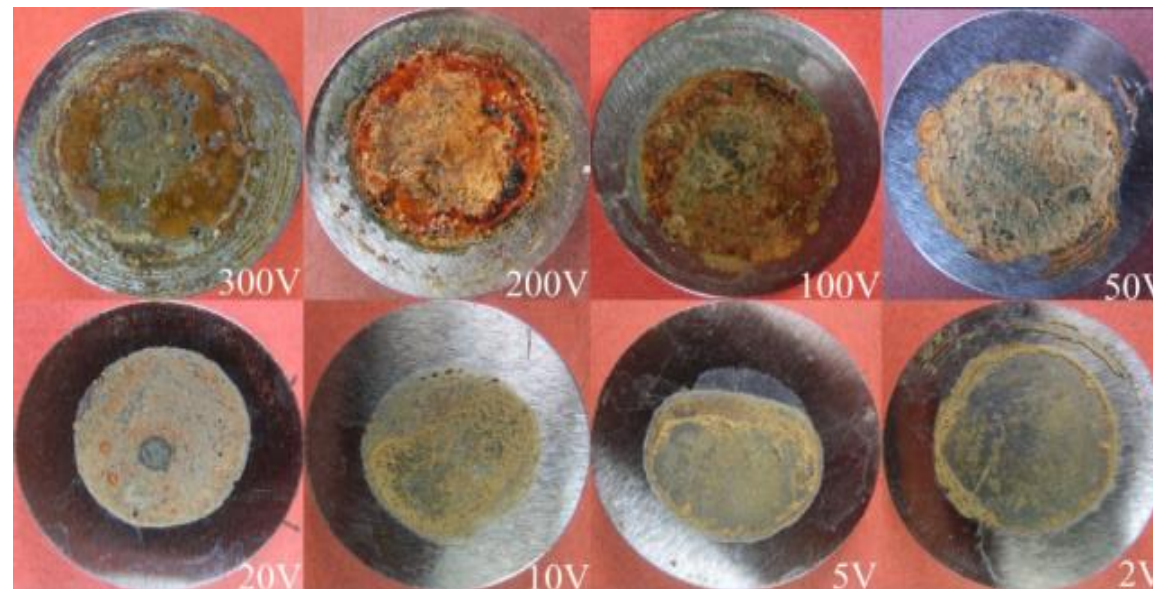
2.2.2 Corrosion Rate of High Voltage DC Interference

- ✓ The corrosion rate increases at first and then decreases with the interference potential rising. The maximum value is 0.04mm/h when the interference potential is 100V. Corrosion product was iron oxide.

- The corrosion rate goes up firstly and then decreased with the interference potential rising. The maximum value was **under 100V interference**.
- The corrosion of pipeline in soil is serious when the interference voltage is **above 50V**.

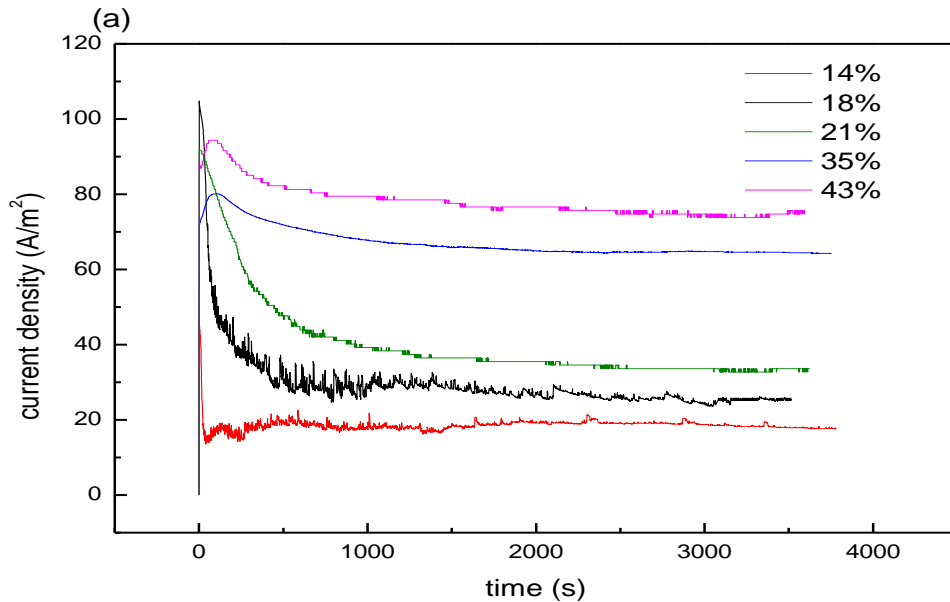
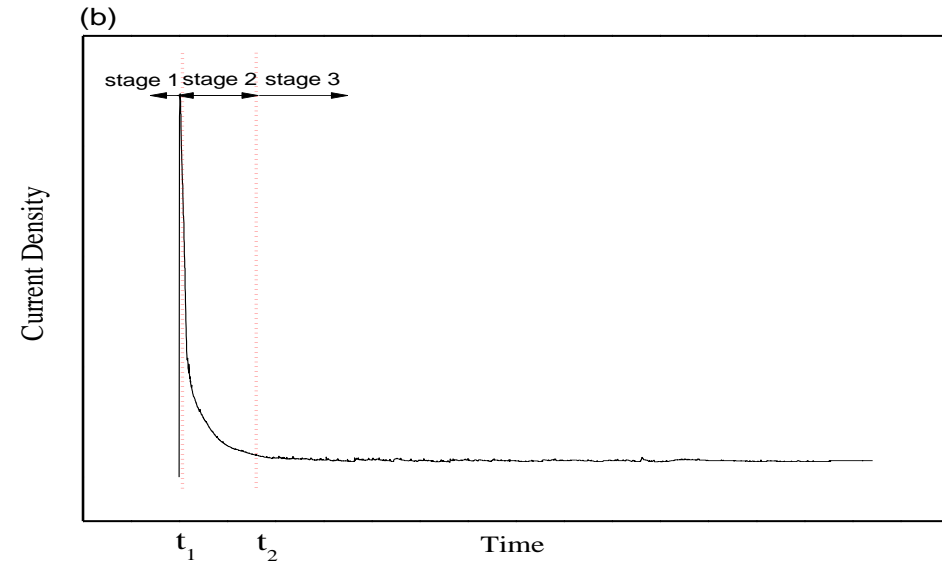
2.2.3 Effects of different soil moisture content on the pipeline corrosion

- ✓ The current density goes up with the increase of moisture content.
- ✓ The current density presents a typical three-stage characteristic when the moisture content between 14~21%, but when the moisture content under the 35~43%, the change is not obviously cause the current density is large.

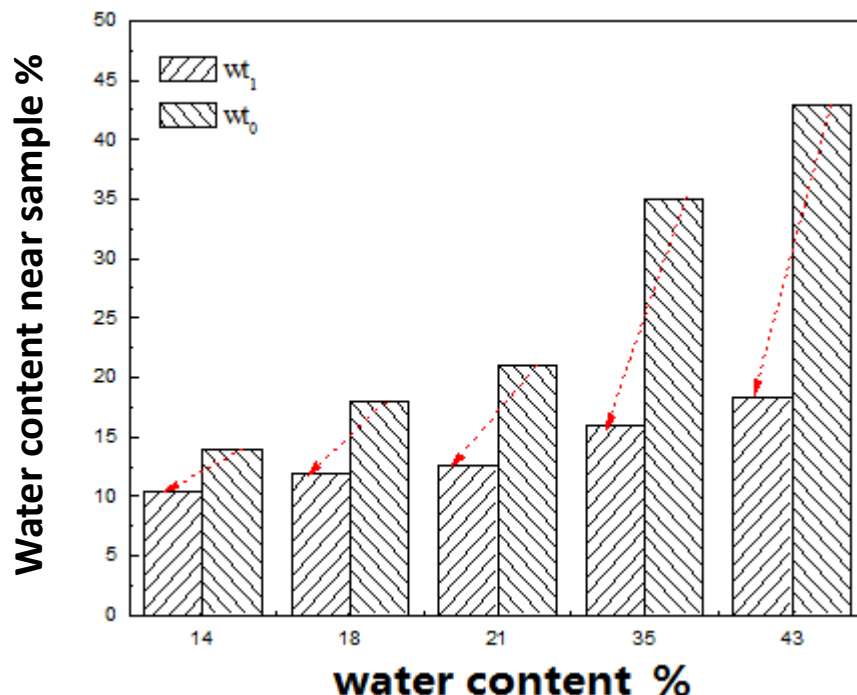
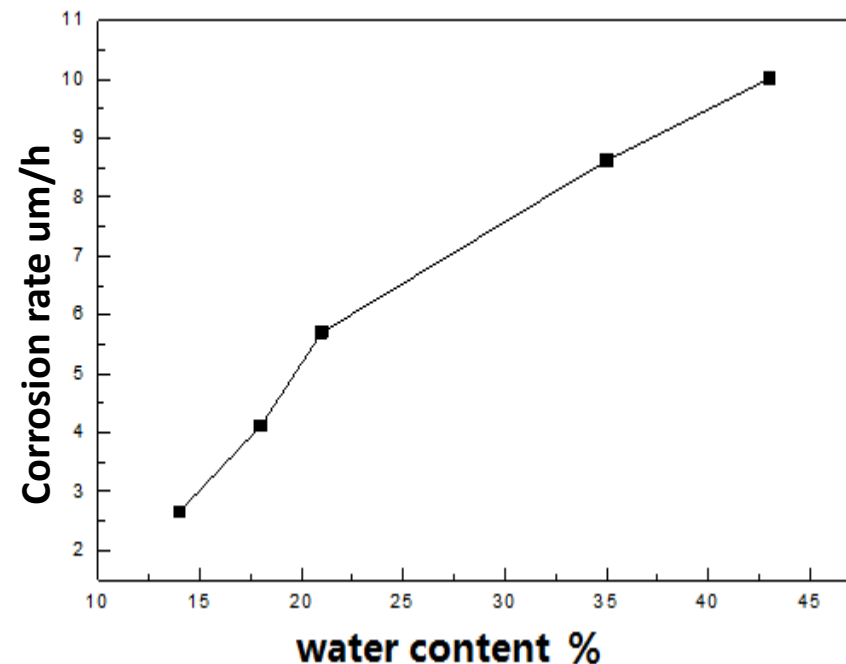
- ✓ After interference the water content wt₁ was **dropped** to wt₀ significantly, and the higher the original water content was, the more obvious the decrease was.
- ✓ The higher the moisture content of the environmental medium, the larger the decrease of the soil moisture content near the surface of the sample after interference.
- ✓ With the increase of **moisture content**, the **corrosion rate increases** gradually.
